Survival Factors Factual in Support of the General Aviation Airbag Study

May 11, 2010

Location: Owyhee, Oregon
Aircraft Type: Husky A-1B
Accident Date: 8/27/2006
Accident Time: 1326 PDT
Accident Number: SEA06FA168
Airbag Equipped: yes

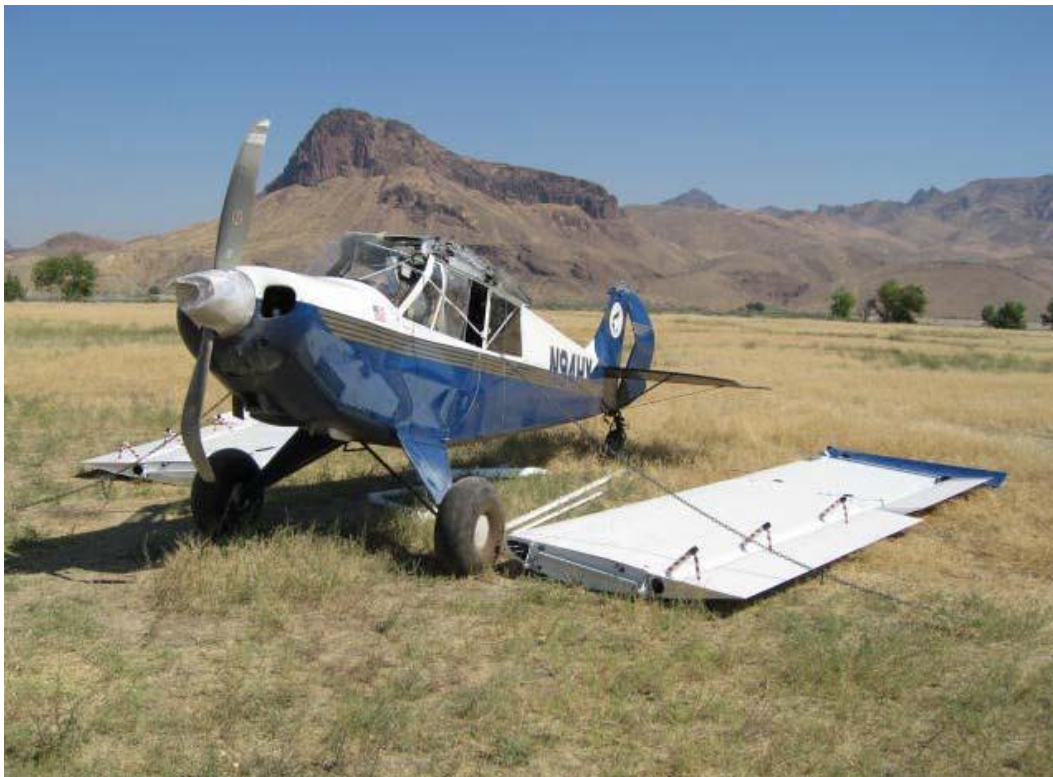
There was substantial damage to the airplane, shown in figure 1, including a bent propeller, dented spinner and engine cowling, damage to the leading edge of the left wing, bent right wing ribs, bent right wing strut, and deformation of the vertical stabilizer and rudder. The forward windscreen was broken and the forward left diagonal post (A-pillar) was compressed outboard and downward about 3 inches (see figure 2), and the roof of the cockpit had minor deformation of approximately one inch. There was a black smudge on the metal support tube that was located directly above the occupant's head and the tube was compressed upward approximately 1/16 inch. There was no damage to the instrument panel.

Figure 1. A photograph showing the wreckage of Aviat Aircraft Inc. Husky A-1B, N94HY that crashed in Owyhee, Oregon (SEA06FA168) (The wings were removed post-crash during the recovery of the aircraft)

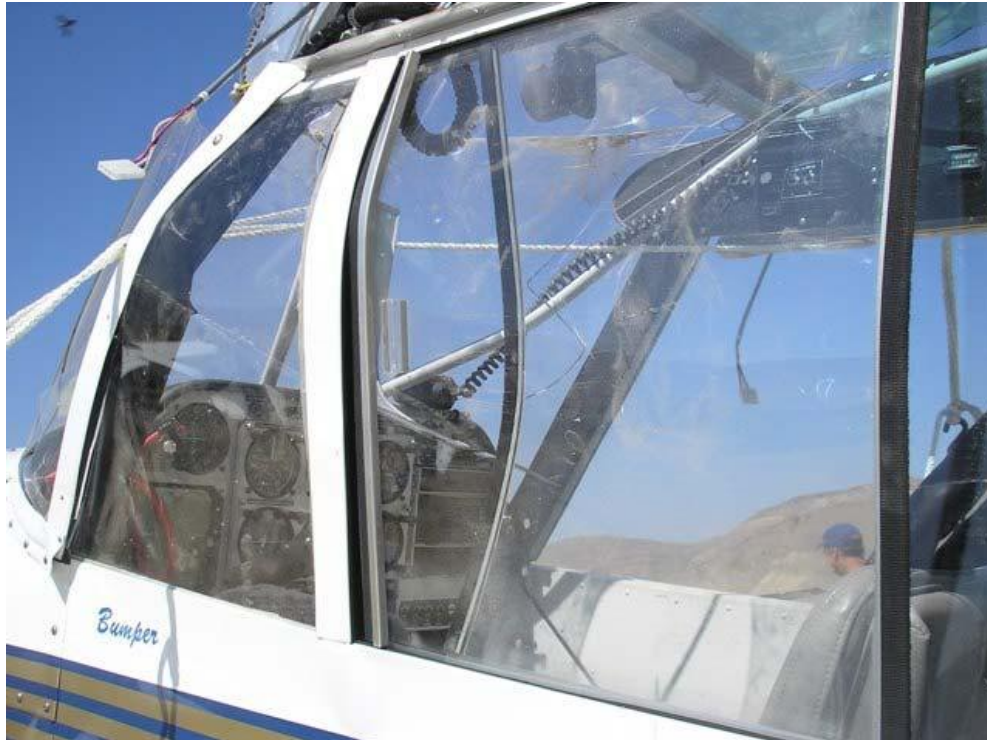
Figure 2. A photograph showing the bent A-pillar and broken windscreen of the Aviat Aircraft Inc. Husky A-1B, N94HY that crashed in Owyhee, Oregon (SEA06FA168)

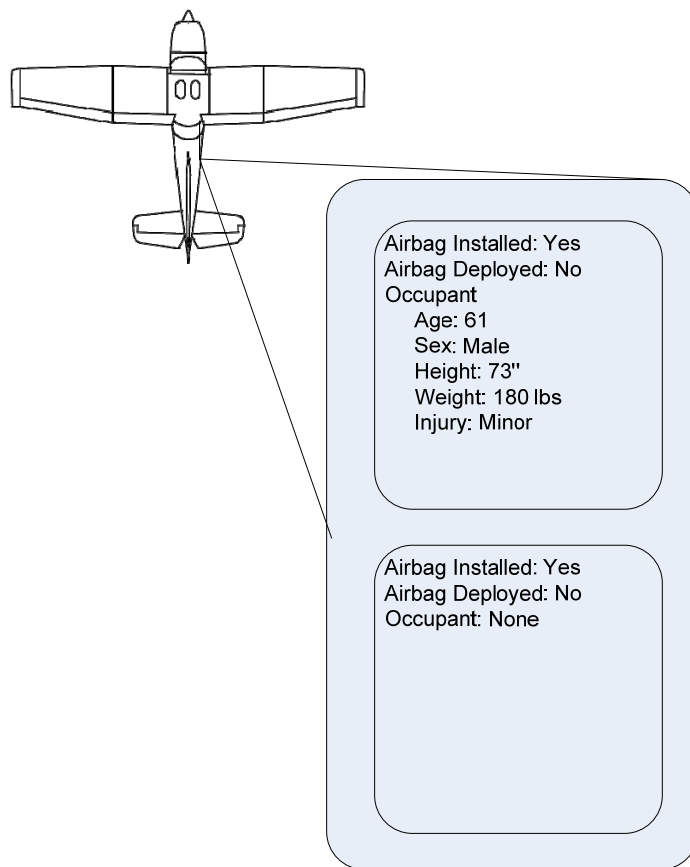
The pilot was seated in the front seat (figure 3). He was 6 feet 1 inch tall, 180 pounds and 61 years old. Initially, the pilot did not document any injuries in a written report. However, during a subsequent interview, the pilot reported that he experienced a minor laceration and bruising to his head, which did not require stitches. The pilot stated the clearance between his head and the ceiling of the cockpit is about 4.5 inches. The pilot self-reported that he was cut by his headset when his head impacted the ceiling of the airplane during the crash. He further commented that the mechanism of his head injury was probably the overhead light assembly and associated cross member/brace. A black smudge on the support beam above the pilot's head also indicated possible transfer of material from the headset during the accident.

The pilot also reported sustaining bruises on his right hip and left shin. He stated that, sitting in a normal position, his shins are about 1.5 inches aft of the lower instrument panel; he believed that was the mechanism for his shin injury.

Figure 3. The seating configuration for the Aviat Husky A-1B, with information about the accident pilot.
